Taxiway Overflight  
Air Canada Flight 759  
Airbus A320-211, C-FKCK  
San Francisco, California  
July 7, 2017

NTSB/AIR-18/01  
PB2018-101561

# Aircraft Incident Report

**Abstract:** This report discusses the July 7, 2017, incident involving Air Canada flight 759, an Airbus A320-211, Canadian registration C-FKCK, which was cleared to land on runway 28R at San Francisco International Airport, San Francisco, California, but instead lined up with parallel taxiway C. Four air carrier airplanes were on taxiway C awaiting clearance to take off from runway 28R. The incident airplane descended to an altitude of 100 ft above ground level and overflew the first airplane on the taxiway. The incident flight crew initiated a go-around, and the airplane reached a minimum altitude of about 60 ft and overflew the second airplane on the taxiway before starting to climb. None of the 5 flight crewmembers and 135 passengers aboard the incident airplane were injured, and the incident airplane was not damaged. Safety issues identified in this report include the need for consistent flight management system autotuning capability within an air carrier's fleet, the need for more effective presentation o

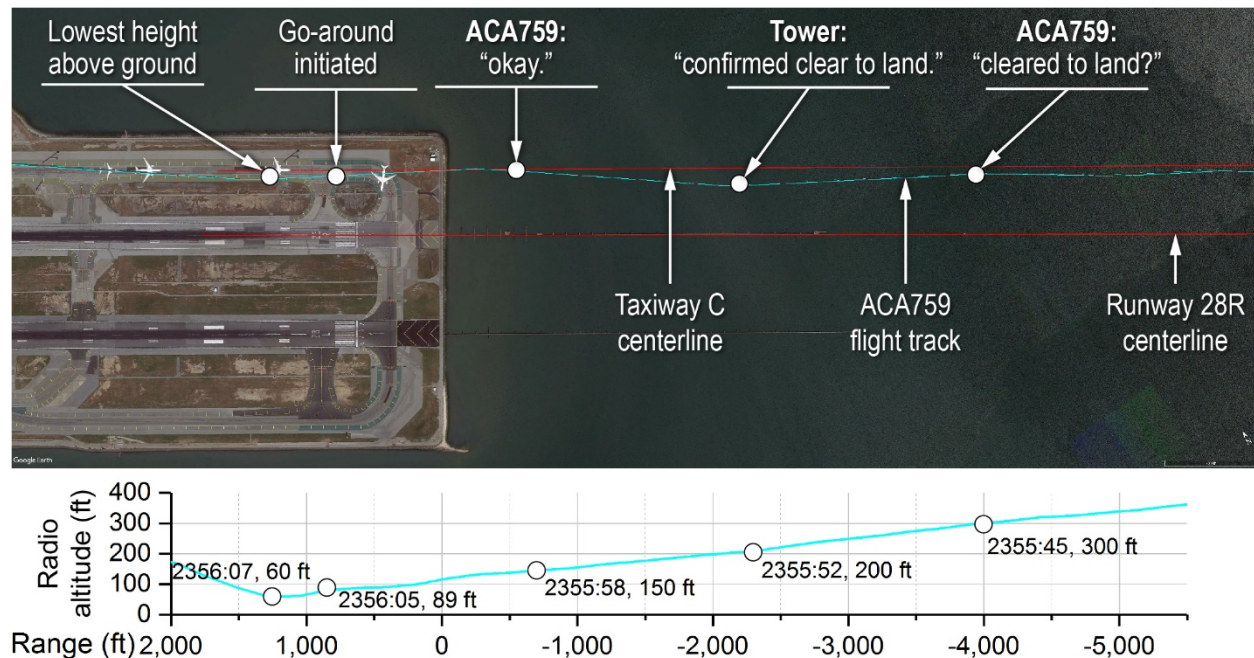
At 2355:52, 1 second after the flight crew completed its transmission, the controller replied, “Air Canada seven five nine confirmed cleared to land runway two eight right. There’s no one on runway two eight right but you.”<sup>25</sup> About that time, the airplane was passing through an altitude of 200 ft and was 2,300 ft (0.38 nautical mile [nm]) from the seawall that protected the airfield from San Francisco Bay.<sup>26</sup> At 2355:58, the flight crew acknowledged the transmission; about that time, the airplane was 500 ft (0.08 nm) from the seawall. Figure 1 shows ACA759’s track before reaching the seawall along with the extended centerlines for runway 28R and taxiway C.

**Figure 1.** ACA759 track over SFO.

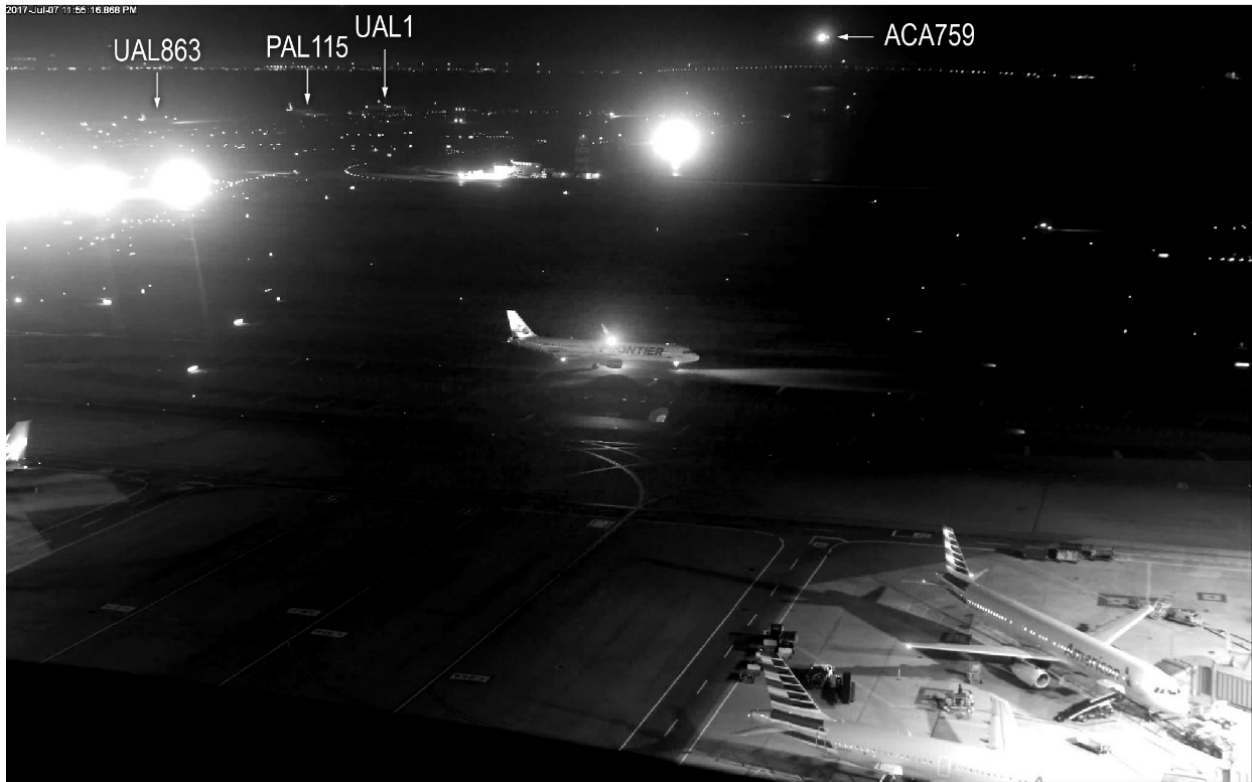
**Figure 6.** ACA759 on final approach to SFO.

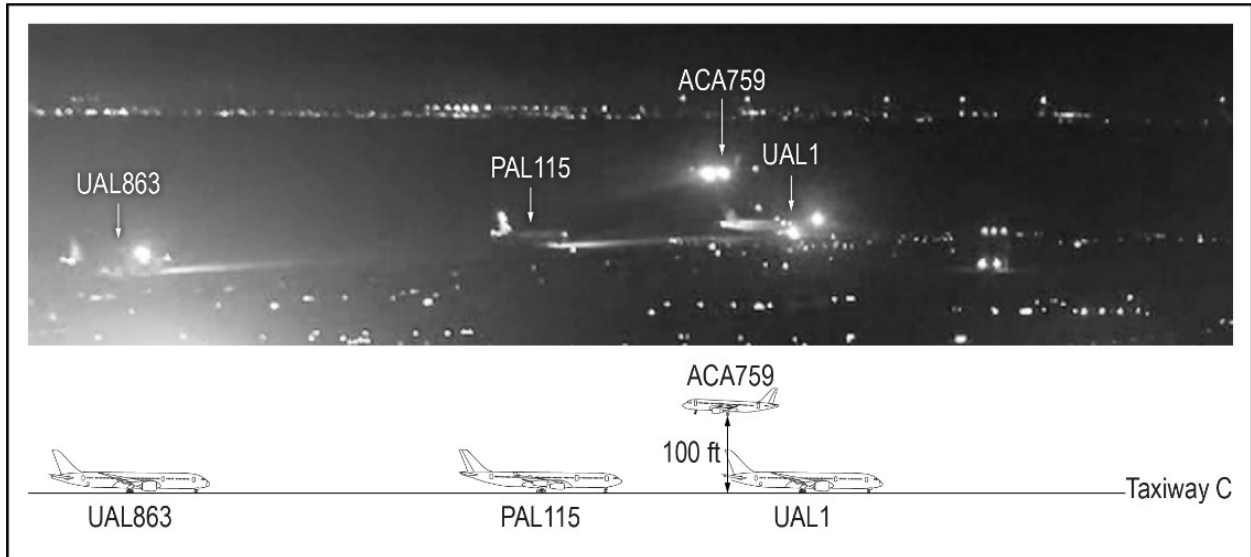
The security video also showed ACA759 passing over the airport seawall and then passing over UAL1 on taxiway C, as shown in figure 7. About this time, the PAL115 flight crew turned on that airplane's landing lights, which illuminated the taxiway between PAL115 and UAL1 as well as the tail and side of the UAL1 airplane. In addition, the security video showed the fuselage of PAL115, which was illuminated by the ACA759 landing lights, and ACA759 descending to its lowest altitude as the airplane passed over PAL115. At that point, the attitude of the ACA759 airplane changed from nose down to nose up, as shown in figure 8. Subsequent frames of the security video showed ACA759 gaining altitude over the taxiway and passing over UAL863 and UAL1118. (UAL863 is shown in figures 7 and 8, but UAL1118 is not shown in those figures).

**Figure 7.** ACA759 passing over UAL1 (top) and relative locations of airplanes (bottom).

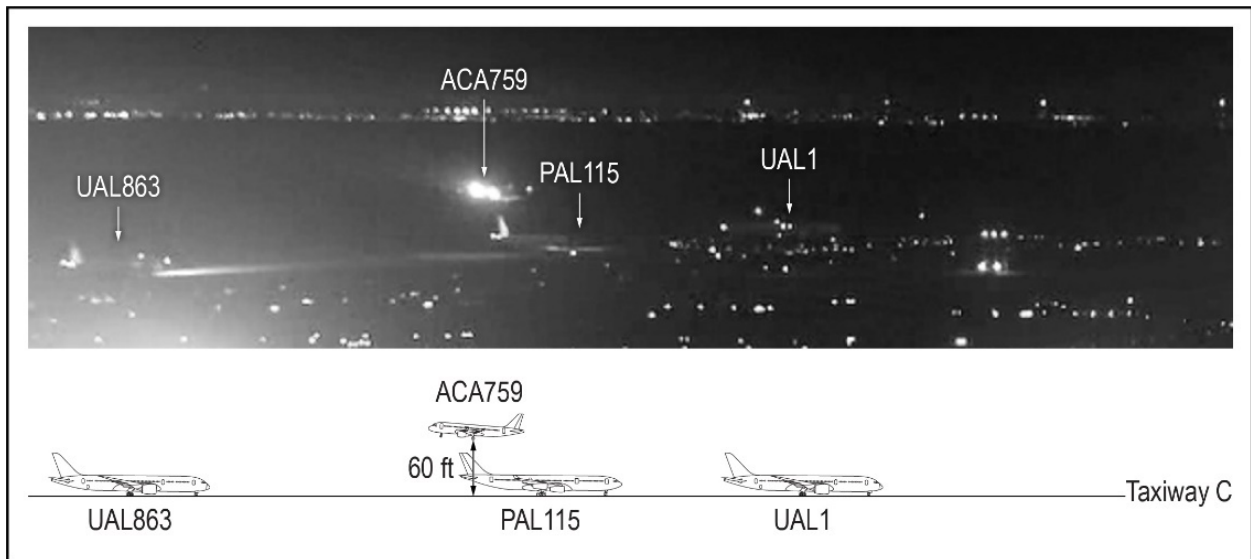
**Figure 8.** ACA759 passing over PAL115 (top) and relative locations of airplanes (bottom).
