Taxiway Overflight  
Air Canada Flight 759  
Airbus A320-211, C-FKCK  
San Francisco, California  
July 7, 2017

NTSB/AIR-18/01  
PB2018-101561

# Aircraft Incident Report

**Abstract:** This report discusses the July 7, 2017, incident involving Air Canada flight 759, an Airbus A320-211, Canadian registration C-FKCK, which was cleared to land on runway 28R at San Francisco International Airport, San Francisco, California, but instead lined up with parallel taxiway C. Four air carrier airplanes were on taxiway C awaiting clearance to take off from runway 28R. The incident airplane descended to an altitude of 100 ft above ground level and overflew the first airplane on the taxiway. The incident flight crew initiated a go-around, and the airplane reached a minimum altitude of about 60 ft and overflew the second airplane on the taxiway before starting to climb. None of the 5 flight crewmembers and 135 passengers aboard the incident airplane were injured, and the incident airplane was not damaged. Safety issues identified in this report include the need for consistent flight management system autotuning capability within an air carrier's fleet, the need for more effective presentation o

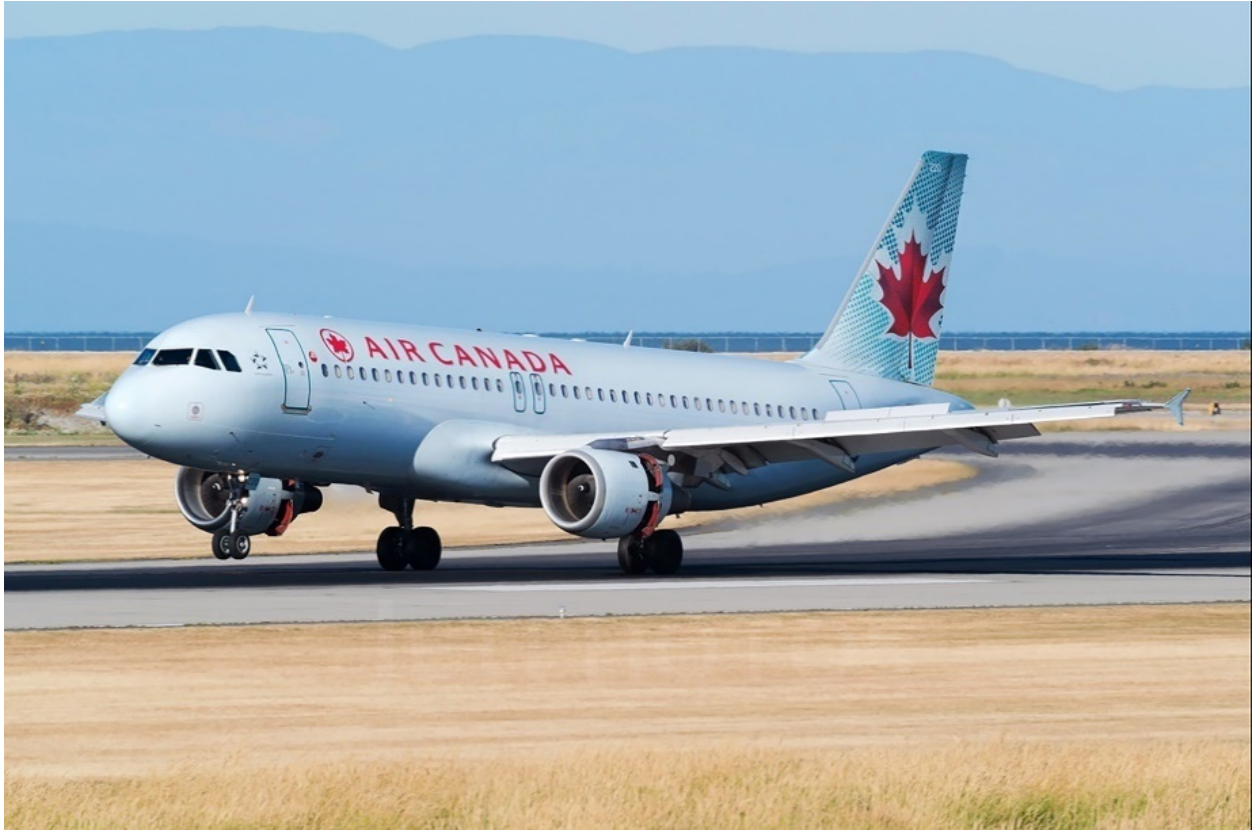
**Figure 2.** Incident airplane.

The incident airplane, shown in figure 2, was owned by GE Capital Aviation Services, which leased the airplane to Air Canada. The airplane’s transport-category airworthiness certificate was dated January 17, 1992. The airplane was powered by two CFM56-5A1 engines and had 2 flight crew seats, 1 jumpseat, 5 cabin crew seats, and 154 passenger seats. The airplane’s last inspection before the incident occurred on June 25, 2017, at which time the airplane had accumulated a total of 82,427 hours of flight time.

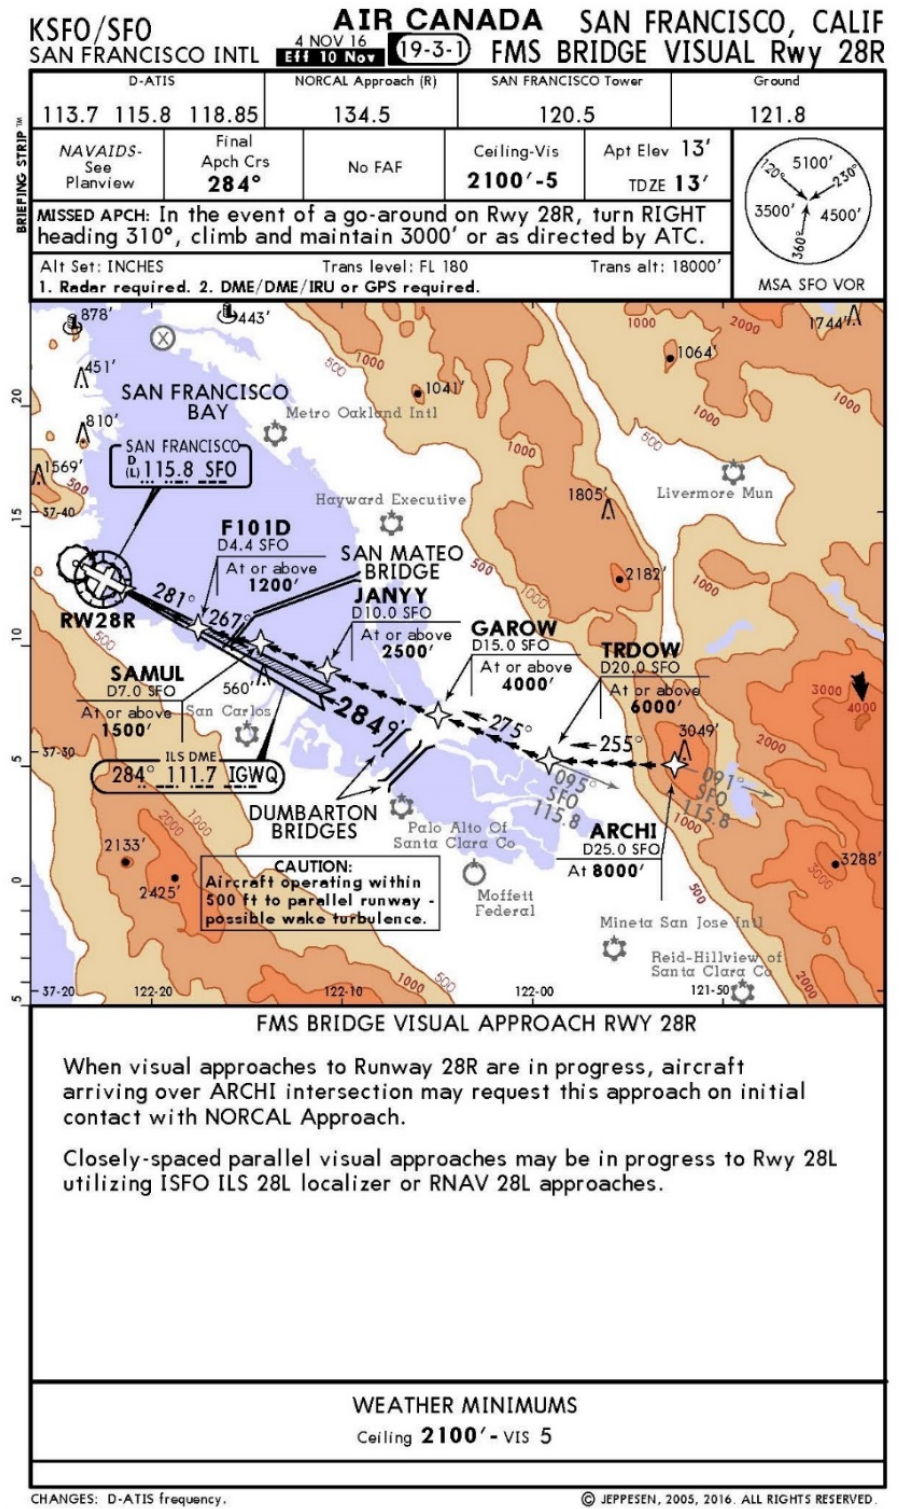
**AIR CANADA** SAN FRANCISCO, CALIF  
 4 NOV 16 **19-3-1A** **Eff 10 Nov** SAN FRANCISCO INTL

outline to each of these figures to emphasize information related to the circumstances of this incident.
